Moultonborough Grange Hall

973 Whittier Highway (Route 25)
Moultonborough NH

Building Condition Assessment

December 2012

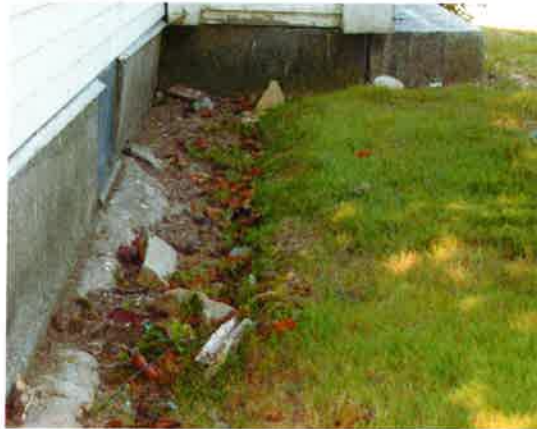
1. Grade around the building. This structure was originally built with adequate grade around the building so that water coming off the roof would be carried away from the building, thereby keeping the cellar dry. Over the years, with various plantings, soil build-up, and the addition of the “his and hers” privy in the early 20th century, the grade around the building now generally slopes towards the building rather than pitching away from the building. This negative slope brings the water collected by the roof and funnels it towards the building, as can be seen in the example (fig. 1) below.

1. Change the grade around the building. The existing grade around the structure should be sloped away from the building, wherever possible. This may require the removal of trees and bushes and their root systems to allow for proper grading. Prior to disturbance of any such areas, the NH Division of Historical Resources should be consulted with regard to potential archaeological resources.

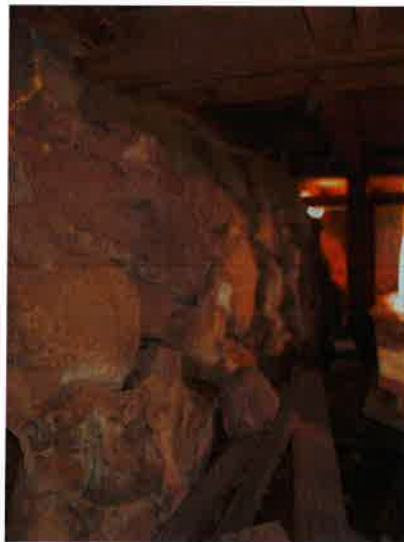
2. Foundation and Deck Framing. The stone foundation and related deck framing are in need of a considerable amount of work. Due to the exterior grade pitching towards the building, as mentioned previously, water has been funneled toward the cellar and has caused significant damage to the foundation walls. There is some damage to the foundation in the northwesterly and the westerly area, but the damage is especially bad in the area of the “his and her” privy. The photograph below (fig. 2) shows 20 feet or more of foundation that could easily collapse into the cellar in the next few years.

2. Foundation and Deck Framing. The foundation and deck framing repairs should be carried out in conjunction with each other due to the need for potential structural repairs when the foundation walls are being repaired, especially in the largest area of damage along the north wall.

The foundation repairs should proceed by first removing all the debris and bad soil types on the cellar floor. Approximately 6 inches of material should be removed and then gravel should be brought in and then floor should be topped with crushed stone.

After any additional shoring up of the deck framing is accomplished in the areas where the stone walls will be repaired, the soil behind the walls should be *carefully* excavated so that the stone foundation can be removed and rebuilt properly. Those repaired areas should then be backfilled with gravel and stone and then the finish grade should be pitched away from the building.

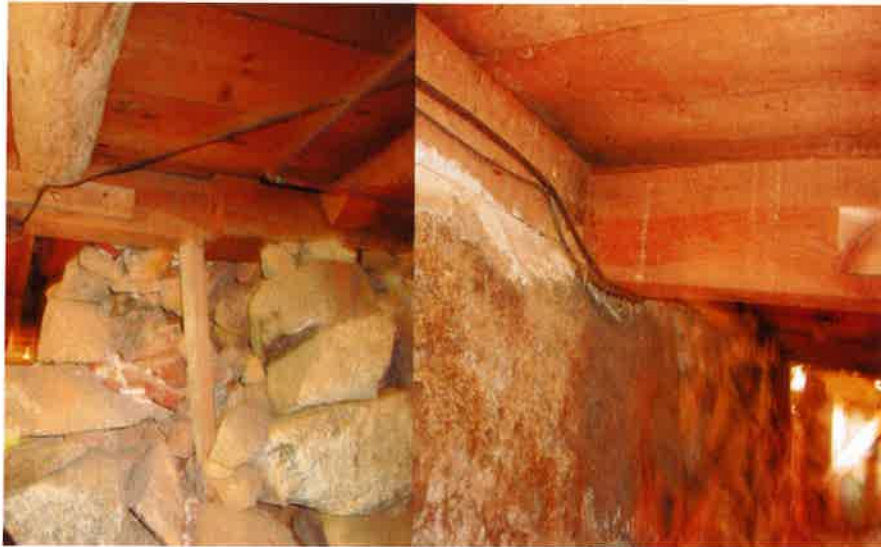
Around 2000, a “good faith” effort was made to replace sills, replace some joists/carriers and shore-up the deck framing (see fig. 3 a/b below). While a substantial sum was clearly expended, the work was never completed and this area is still a major concern. Some of the old log floor joists were “sistered” but only one side of the new joist was attached back to the sill, and major carriers were “ended out” (replacement pieces were merely butted-up to the old carriers and simply “toe-nailed” together), without having been connected with steel for adequate support.

New concrete piers were installed in the cellar floor to allow for additional posts for shoring purposes under the old and new floor joists. While this was a good idea, the new shoring material is not adequately attached to the existing old/new joist and at last one section has fallen to the cellar floor. Also, when installing the new concrete piers, the soil was excavated around the area and piled up wherever, rather than being removed. Currently, with the water being funneled towards the building, the water is then subsequently pitched towards these new concrete piers.

The deck framing repairs should consist of individually constructed and installed steel brackets that will adequately make the various connections in the deck framing structurally appropriate and sound. A significant number of these steel brackets have to be custom fabricated and appropriately installed. The posts and carriers that have been installed to support the joists should also be appropriately attached to the existing joists so that they will not fall out.

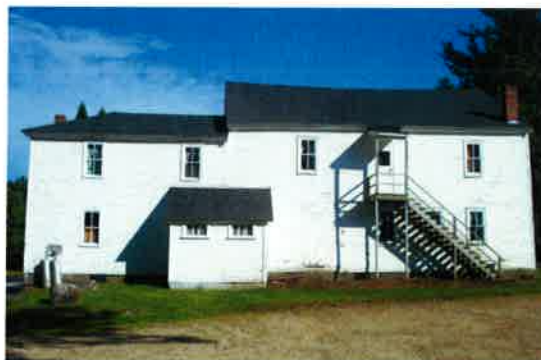
3. Roof System. The existing roof system is in imminent danger of complete failure and collapse especially under any snow load (inspection July-September 2012, visible from exterior, fig. 4). The problems of the roof system date back to the late 19th/early 20th century when the center chimney was removed, the second floor partitions were removed, and the collar ties (the timber framing that “ties” the front wall to the back wall) were removed in order to install a vaulted ceiling.

3. Roof System Emergency Stabilization. The existing roof should be stabilized before snow due to the fact that the steel rod system has failed at the connections and any increase of load on the roof would most likely result in the roof collapsing and thereby causing significant and irreversible damage to the entire structure (July – September inspection, see also Garvin report).

The roof system should be temporarily strengthened through the installation and use of at least five heavy duty “come-a-longs” to keep the shed walls of the structure from spreading. Commercial type wall stabilizers may also be located along the sidewalls and attached to the floor to help keep the building from spreading. All of this work will require the careful removal of some of the interior beaded sheathing and also the removal of some of the exterior trim (this work completed October 2012).

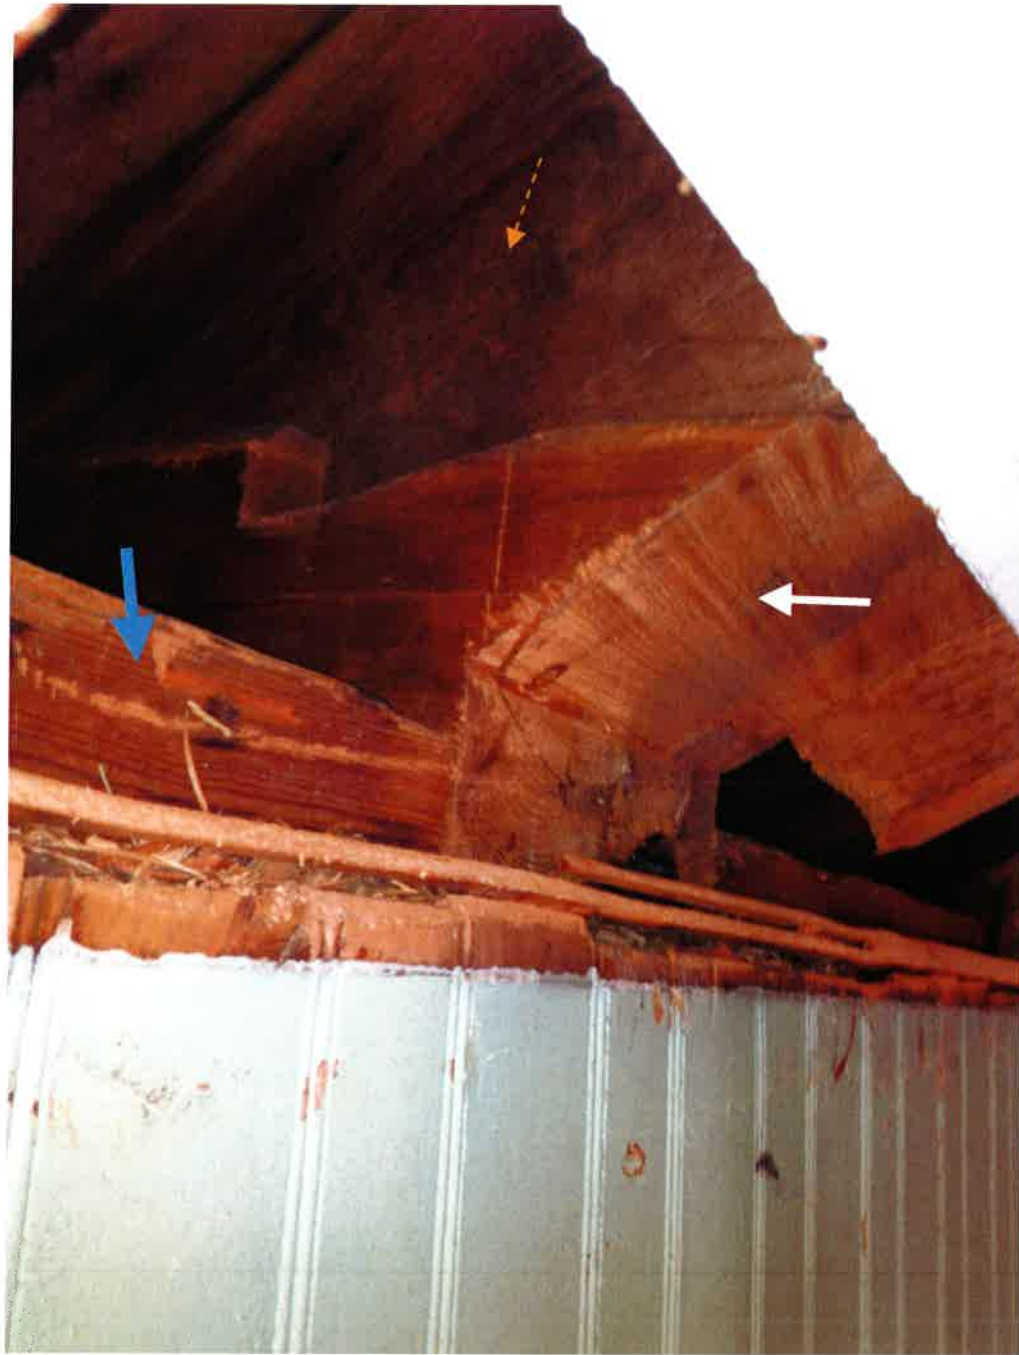
In this photograph taken during stabilization in October (fig. 5), the orange arrow shows the rafter with a "birds-mouth" connection to the remainder of the collar tie beam that was cut off (white arrow) when the ceiling height was raised. The blue arrow indicates the top plate into which the collar tie beam is notched so that the building does not spread apart. The existing plaster with lath was covered over with "furring" strips and the beaded interior sheathing was then applied.

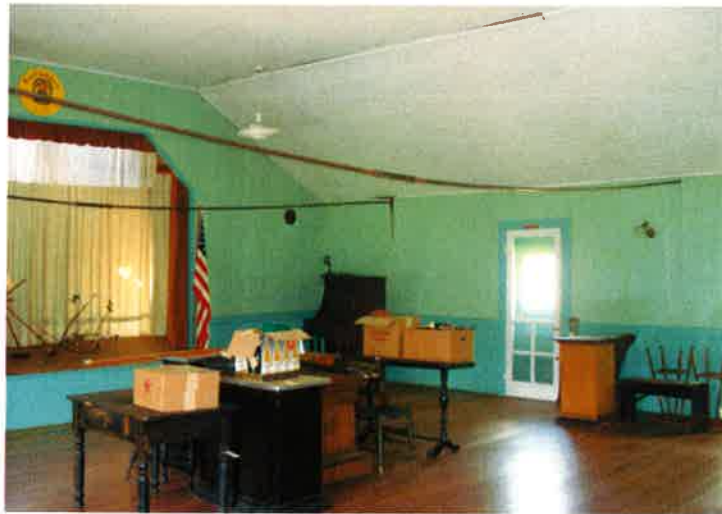
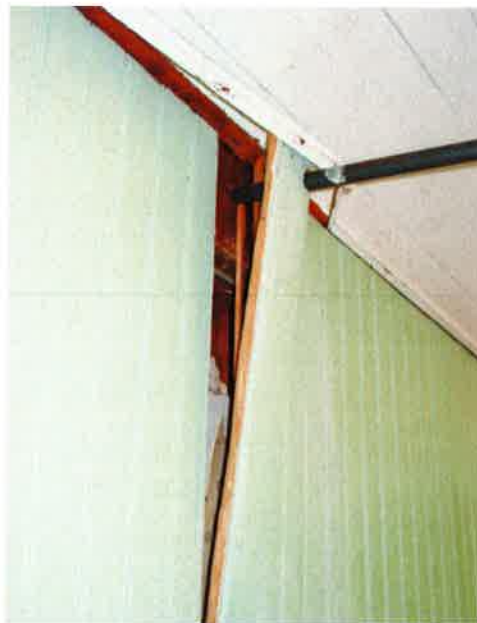
In early 2012, it was discovered that the two existing steel rods had apparently pulled out or away from their original connections on the shed sides of the building. While the rods were still in place, they were not under tension and could be seen drooping under their own dead load weight (figs. 6 and 7, interior photographs taken August 2012 prior to inspection/stabilization).

In early September 2012, as part of this partial building assessment, measurements were taken across the building at the plate height as well as across the floor in the corresponding areas. It was found that the building has spread apart at the plate height from between 4 ½ to 5 ½ inches.

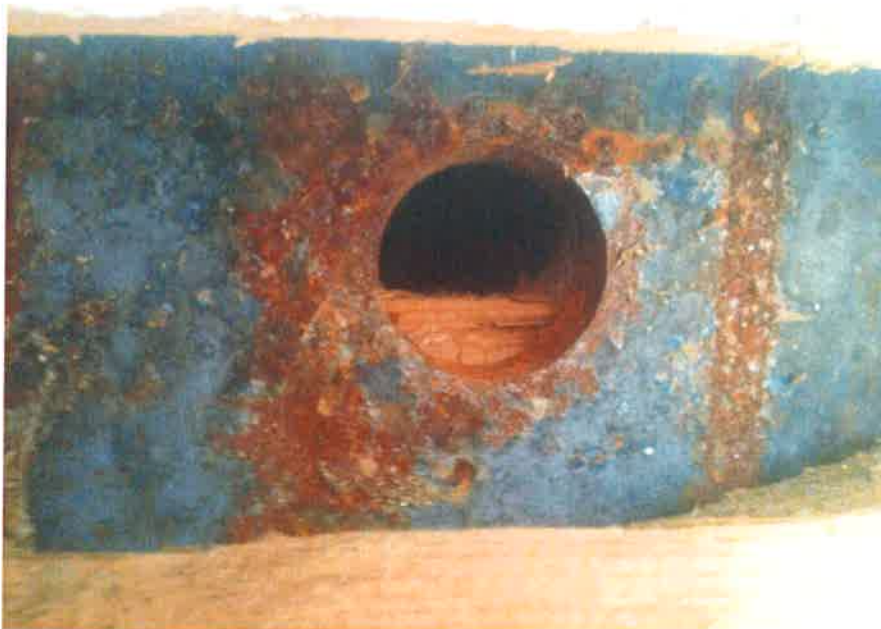
Upon the removal of the exterior siding on the northerly side during priority stabilization in late October, in the location of the iron rod connection to the wood timber plate, it was discovered that the iron rods had pulled through the iron plates set into the wood timber plate and were within an inch of completely falling out onto the interior of the Grange building's floor (fig 8).

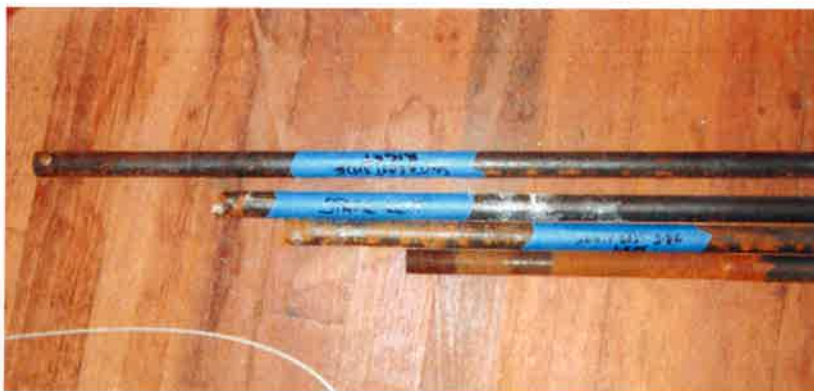
When the turnbuckles were removed so that the rods could be brought into the building, it was quickly discovered that the connections on the exterior were not finished with a threaded rod and nut as this connection is typically made. Instead, the connection on the outside of the plate was made by simply drilling a hole through the rod and by inserting a one-quarter inch (1/4") steel pin. It was only the strength of these one-quarter inch (1/4") steel pins, as long as they lasted, that was keeping the building from spreading apart (fig. 9, pins after removal during stabilization process).

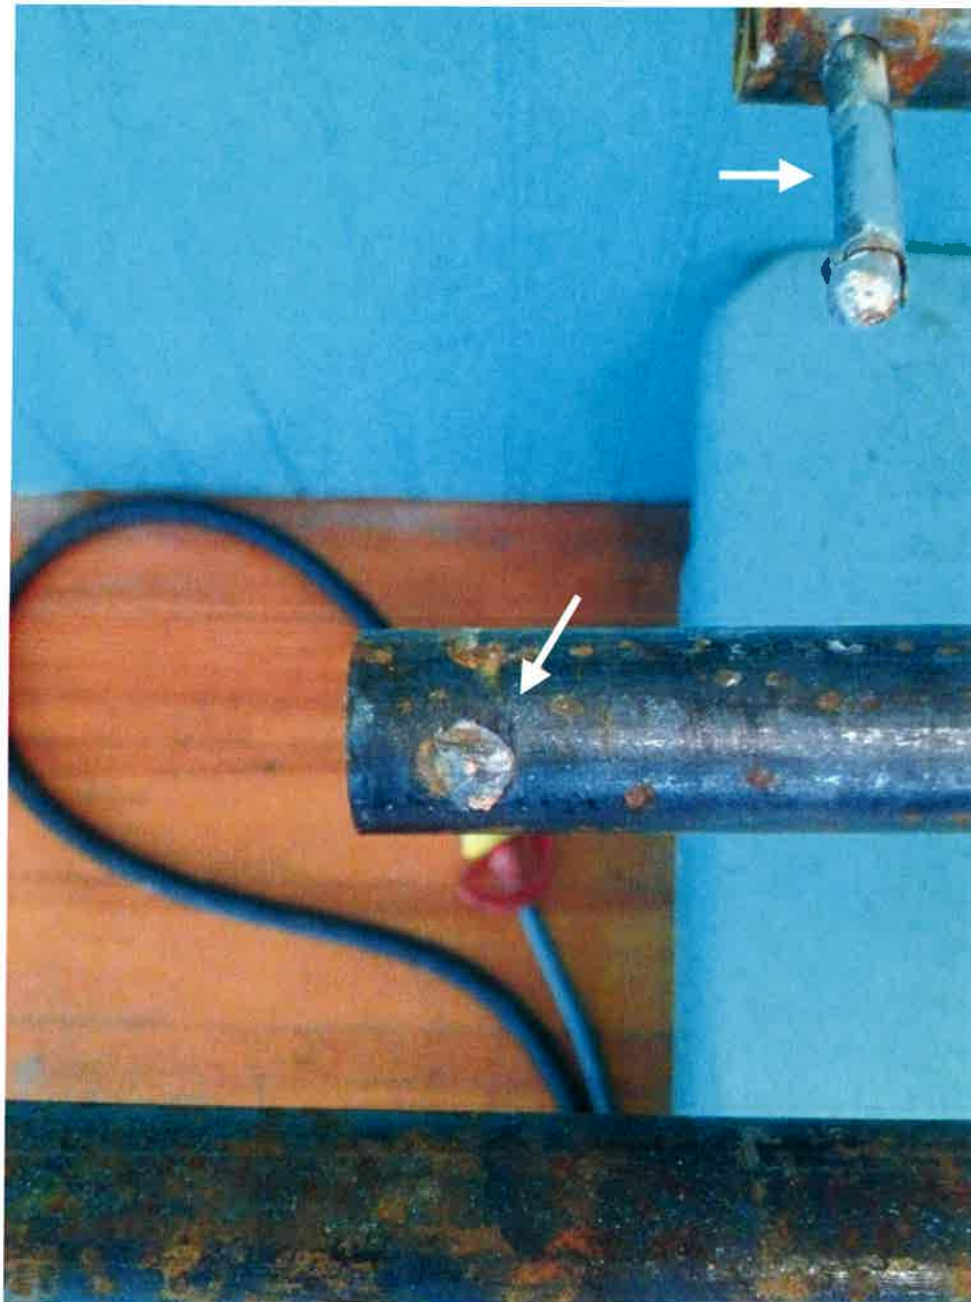
The photograph below (fig. 10) shows one of the rods where the pin had completely sheared off and then had pulled through the steel plate. In the upper right hand side of the photograph, one can see a pin that was distorted from the outward forces of the roof system.

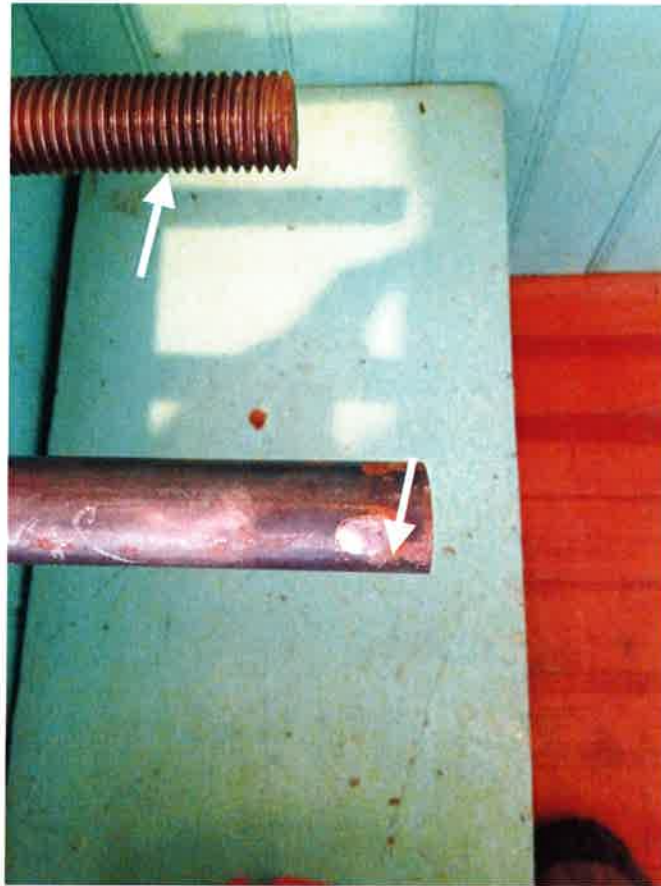
In this photograph (fig. 11), the lower arrow points toward a sheared-off pin on an unthreaded rod. The arrow near the top shows a section of the rod that was threaded for the turnbuckles. It is interesting that while the obviously the “technology” existed for threaded rods (when the upper floors of the building were renovated into an auditorium space), as is shown in the threaded rod at the top, a decision was made to utilize a one quarter inch (1/4”) pin instead of a threaded nut.

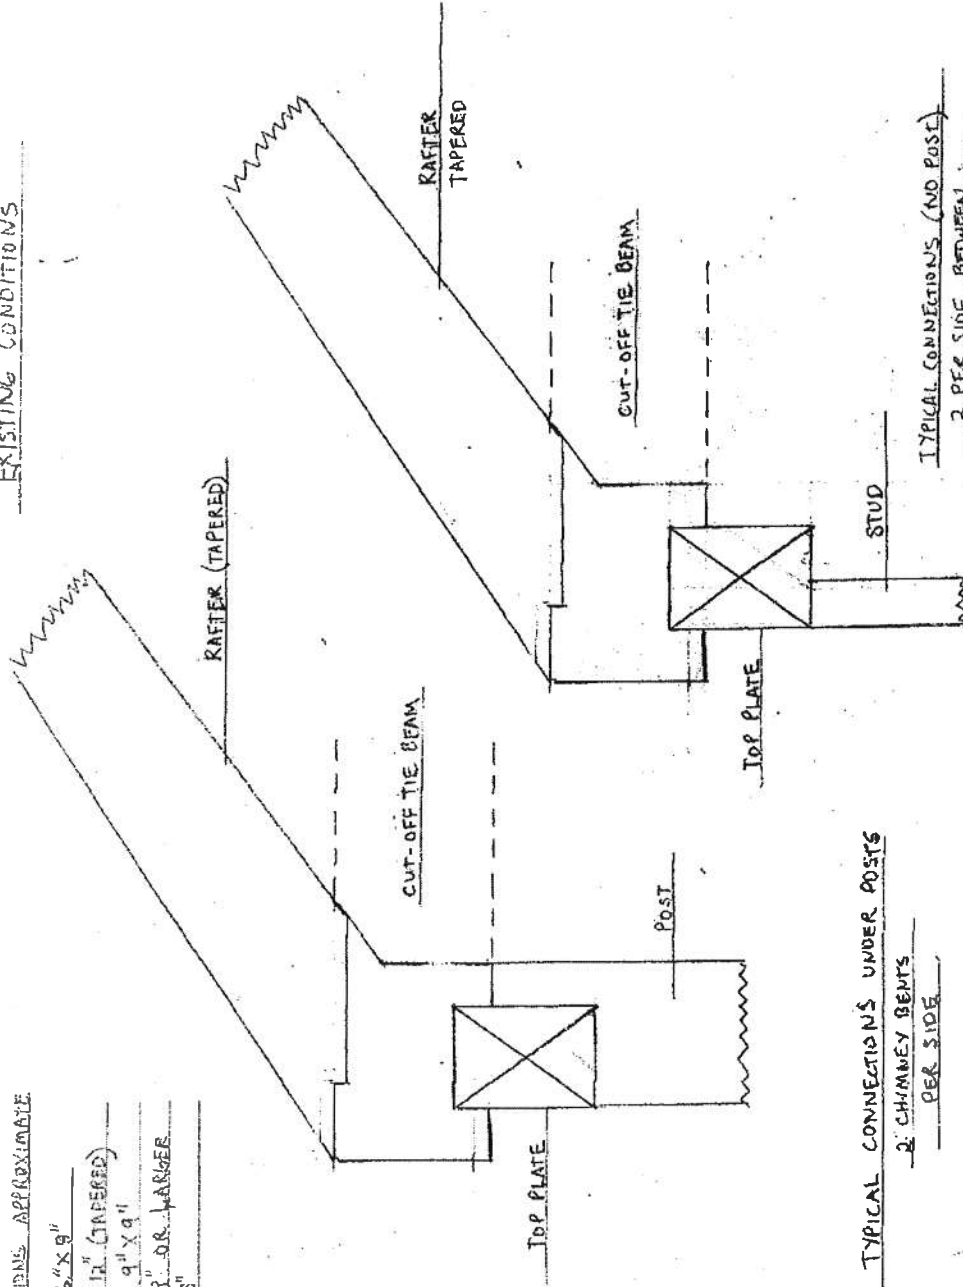
EXISTING CONDITIONS

During our site visit you told us the Grange Hall was originally constructed with tie-beams at the rafter ends and since that time they have been cut off, flush with the wall below. The walls supporting the rafters are bowed outwards due to thrust from the unrestrained rafters. Subsequently, tie-rods were added to the Hall, but failed to alleviate the problem. At this time you propose to repair to restrain the thrust from the rafters utilizing tie-rods attached to the wall top plate and rafters with a steel bracket.

The sketches you provided are generally acceptable as a repair to the cut off tie-beam with the following exceptions/requirements:

- All bolts shall be $\frac{3}{4}$ ".
- Bolts shall be installed in two rows with a minimum center of bolts spacing of 2.25" between bolts, 3" from the inside rafter/post edge, and 1.25" from the outside rafter/post edge.
- Tie-beam shall be $\frac{1}{2}$ " min. steel rod.
- Tie-rod plate washer shall be 5"x5"x $\frac{1}{4}$ " min.
